**REPORT OF
WHIRLPOOL CORPORATION IMPROVEMENTS TO
GROVER & MILLER PROPERTIES
CLYDE, OHIO**

AUGUST 2002

**Whirlpool Corporation
2000 North M-63
Benton Harbor, Michigan 49022**

**Golder Associates Inc.
Project Number 993-8534**

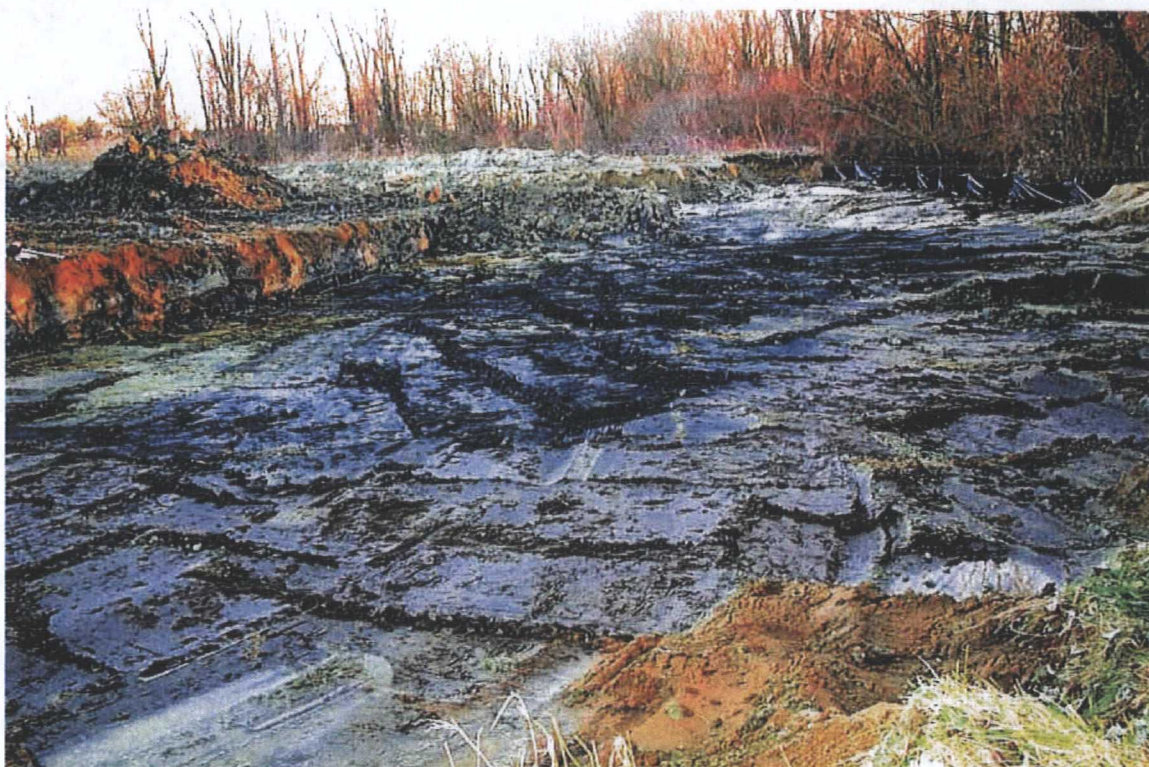
Photo 3: Area 1- View to the south from the northwest corner.

Excavation proceeded by removing the residuals that were exposed along the top of the creek bank. The residuals along the top of the creek bank were found to be approximately three to five feet thick (Photos 3 and 4). This activity was completed on December 21, 2001. Excavation then continued in a general west to east direction until reaching the end of visible extent of residuals to the north, east, and south (Photos 5 through 16). No visible residuals were observed beyond the north and south Grover property lines with the Karr and Webb properties, respectively. During excavation, a thin layer of overburden soil (e.g., < 1 foot) was removed along with the residuals, as was approximately 2 to 3 inches of undercut native soil in order to achieve complete removal of the residuals.

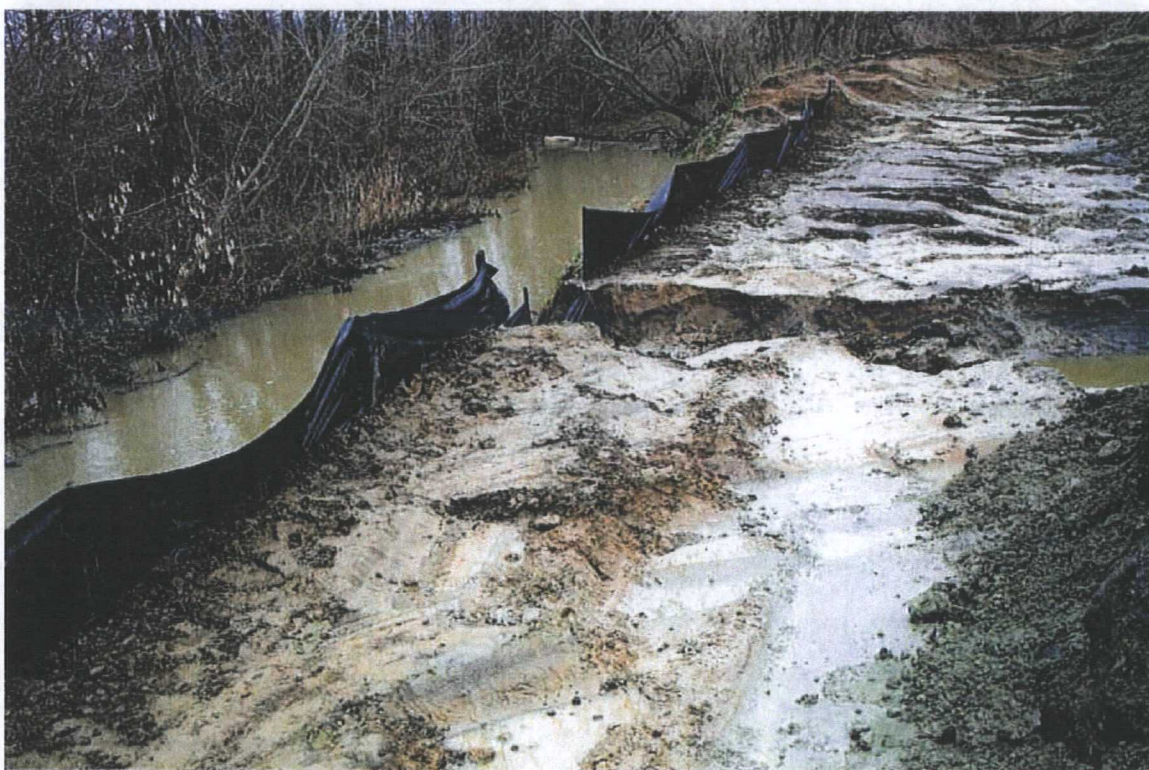
Photo 4: Area 1- View of silt fence to the north.

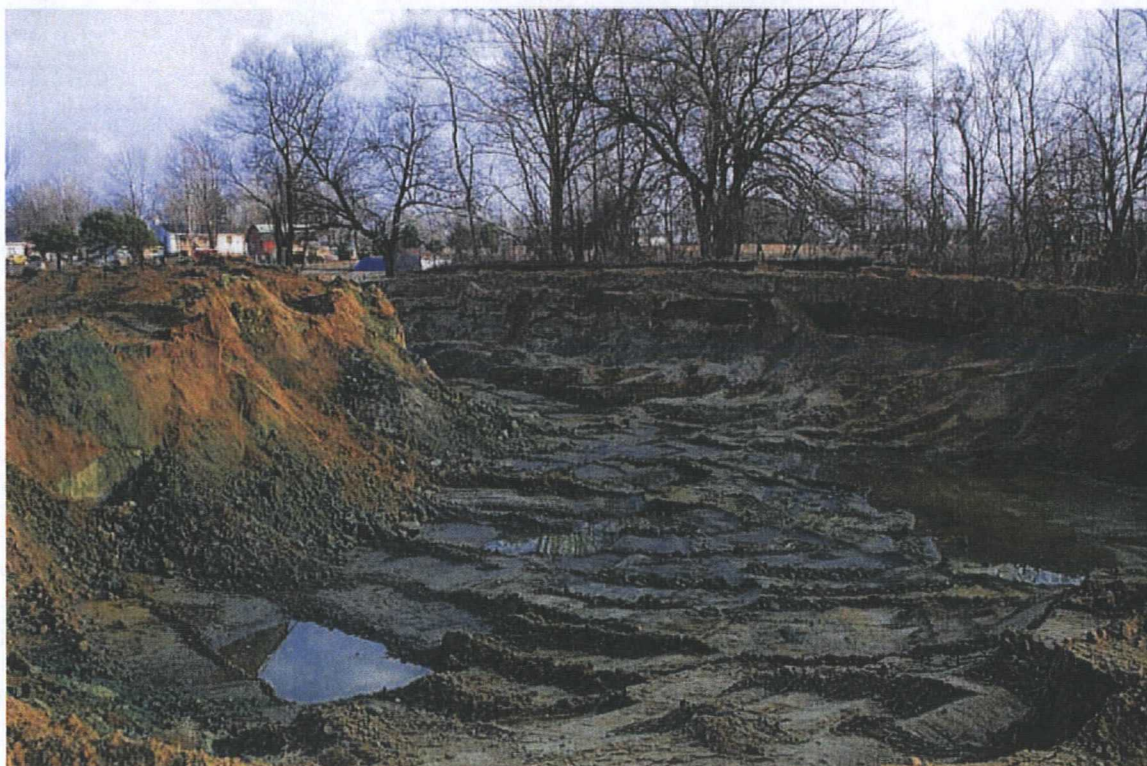
Photo 28: Area 2- View to the southeast from the northwest corner.

Excavation began on the east boundary of Area 2. The residuals here were found to be three to four feet thick. Maverick began the excavation by trenching around the perimeter of the area in order to verify the extent of the residuals. Test pits were excavated to determine the depth of residuals. Excavation continued in a general east to west direction (Photos 21 through 26) until Maverick reached the end of visible residuals to the north, west, and south. No Area 2 residuals were encountered beyond the southern boundaries of the Grover or Miller properties (Photos 28 and 31).

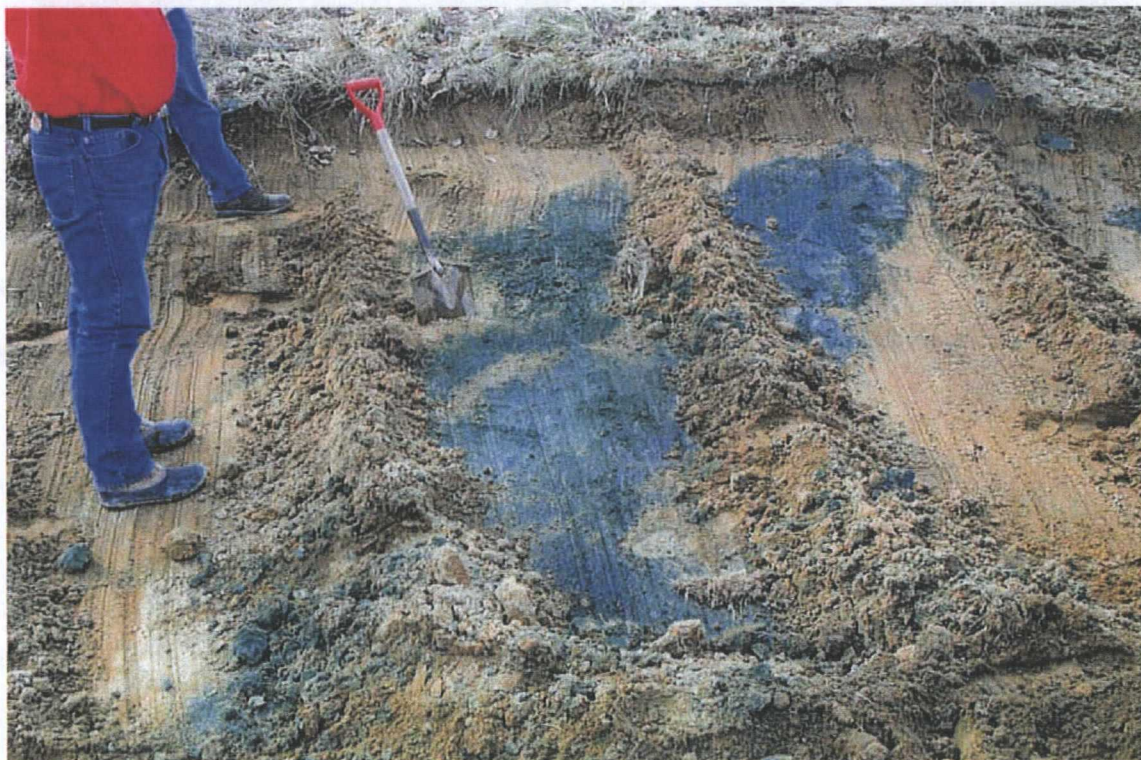
Photo 30: Area 2- View to north of residuals imbedded in overburden.

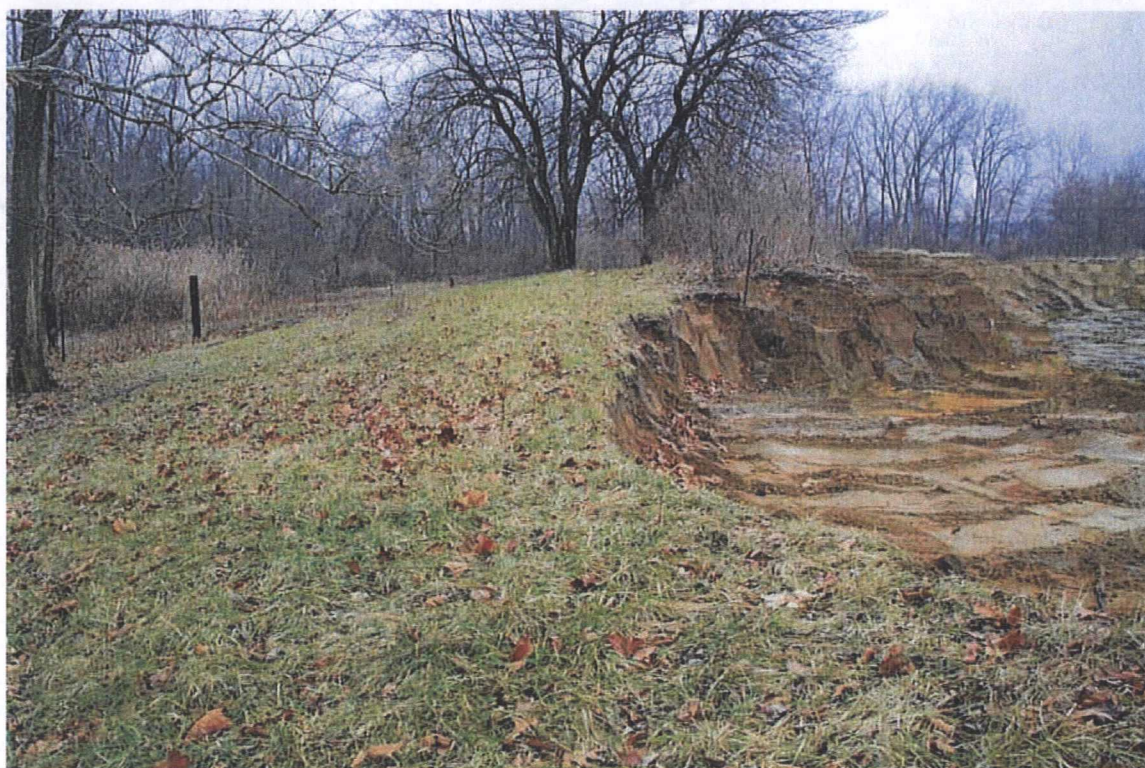
Photo 31: Area 2- View to the west down the south property.

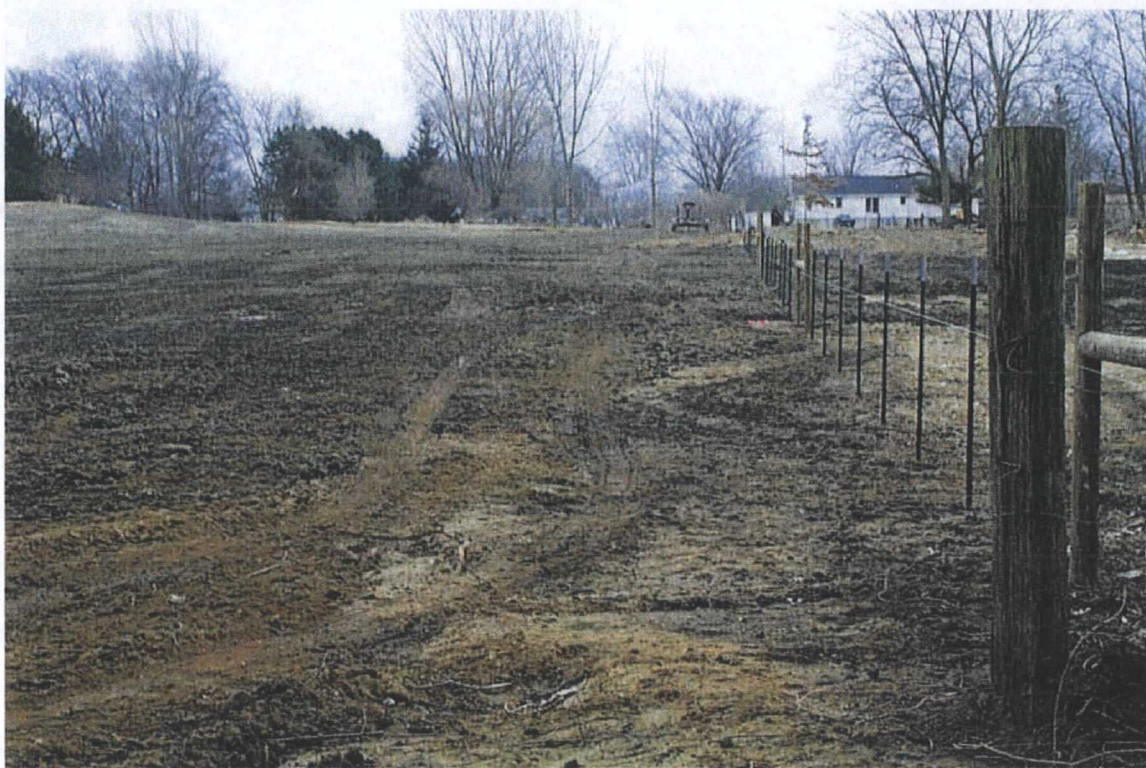
Photo 7: Area 1- View of new fence to the east along south property line.

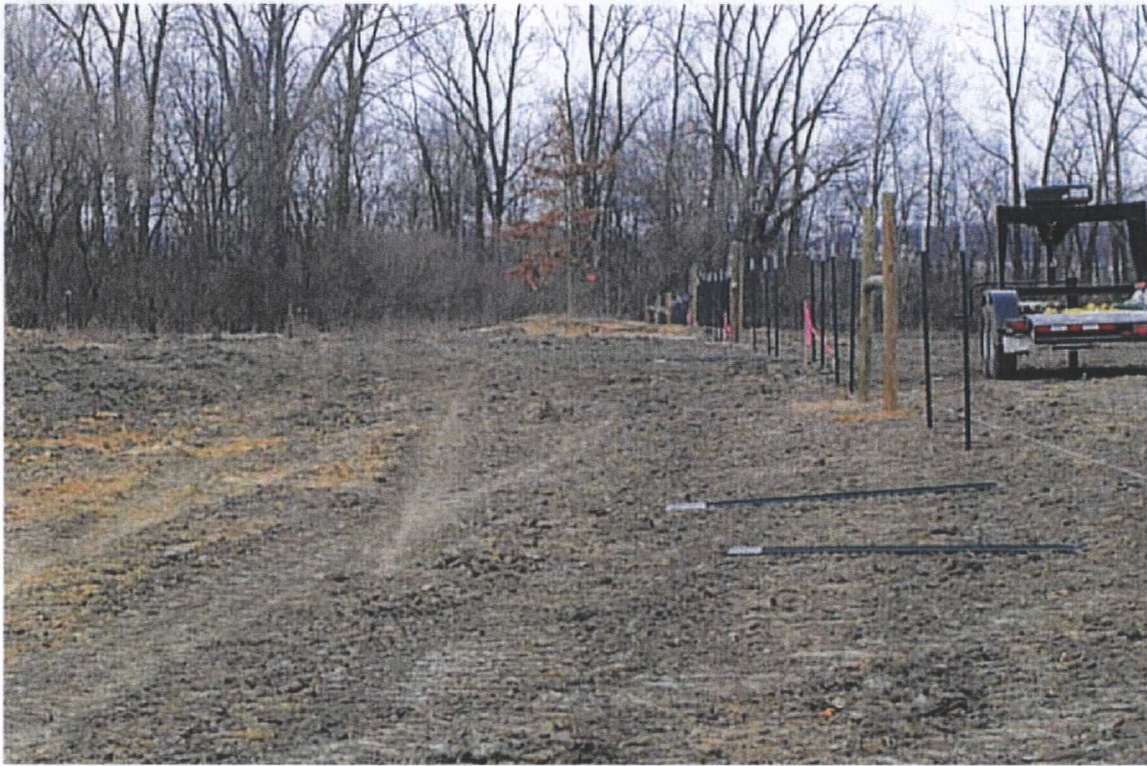
Photo 9: Area 1- View to west of restored Webb excavation.

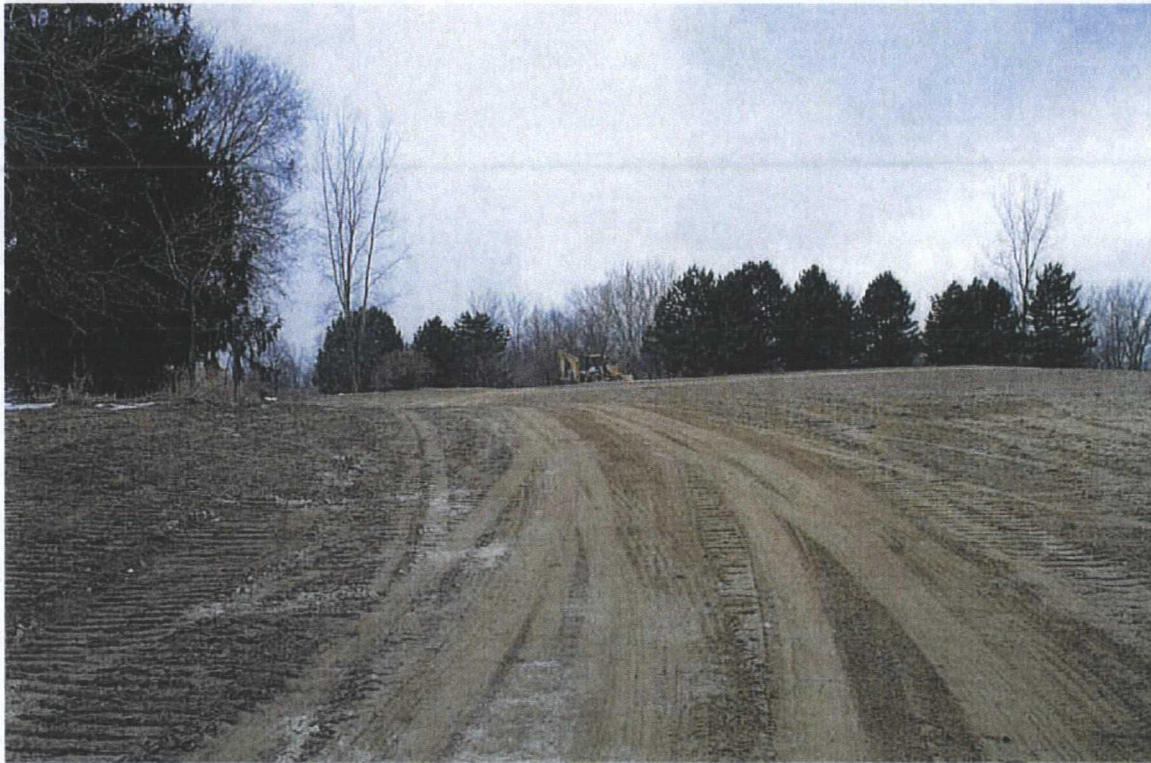
Photo 21: Area 2- View to the southwest of removed haul road on Karr property. (GAI Photo Dcp-905)
